# Fractures and Their Distribution in the Tills of Ohio<sup>1</sup>

C. SCOTT BROCKMAN AND JOHN P. SZABO, Ohio Department of Natural Resources, Division of Geological Survey, 4383 Fountain Square Drive, Columbus, OH 43224, and Department of Geology, University of Akron, Akron, OH 44325

OHIO J SCI 100 (3/4):39–55, 2000

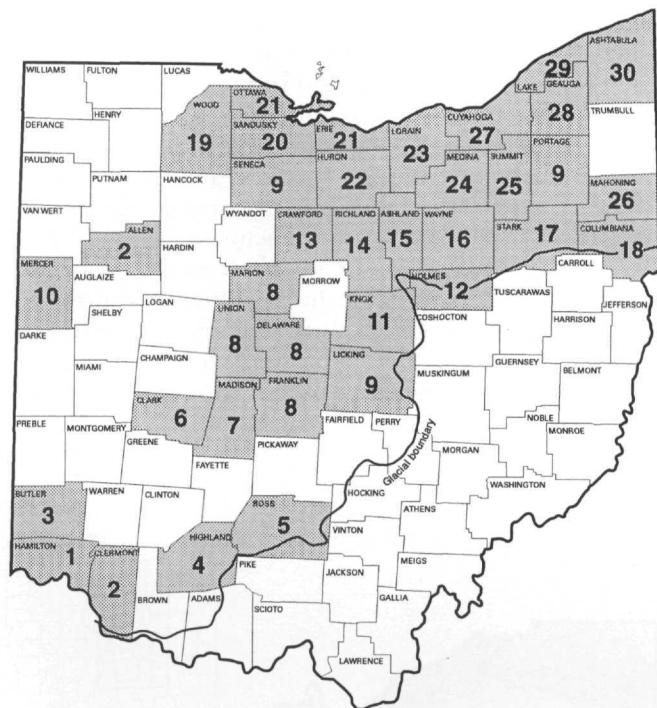
FIGURE 4. Distribution of the published and documented locations of fractures in till in Ohio. In some publications, specific sites are noted; more commonly, however, references to fractures are generalized to county only. The lack of data in any county does not indicate an absence of fractures, only that no data are available for that county. 1. Brockman 1983; 2. Brockman file data; 3. Goldstein 1968. 4. Rosen-green 1974; 5. Quinn and Goldthwait 1985; 6. Weatherington-Rice 1998; 7. Brockman and Szabo 2000 (documented in this study); 8. Brockman 1994; 9. Michael Angle 1999, personal communication; 10. Weatherington-Rice 1999, personal communication; 11. Viani and Szabo 1987; 12. White 1973; 13. Totten 1987; 14. Totten 1973; 15. White 1977; 16. White 1967; 17. DeLong and White 1963; 18. White and Totten 1985; 19. Blevins and Wilding 1968; 20. Ohio Division of Geological Survey core record 3051, Sandusky County, Ballville Township; 21. Richard Pavey 1999, personal communication; 22. Totten 1985; 23. Totten 1989; 24. Totten 1988b; 25. White 1984; 26. Totten and White 1987; 27. Ford 1987; 28. Totten 1988a; 29. White 1980; 30. White and Totten 1979.

Although fracture information found in Ohio's geologic literature is more general than that from either core records or the test pit, it covers a much wider geographic area. Fractures in unoxidized till have been recorded in published reports and field notes from at least 37 Ohio counties (Fig. 4), which include every surficial Illinoian and Wisconsin till unit on the *Quaternary Geology of Ohio* map (Pavey and others 1999). The locations of these records reflect areas of DGS mapping projects, rather than an actual absence of fractures in counties not listed. These fractured-till units represent a great variety of ages, facies, and textures, including Wisconsin- and Illinoian-age tills and lodgement, melt-out, water-laid, and wave-planed

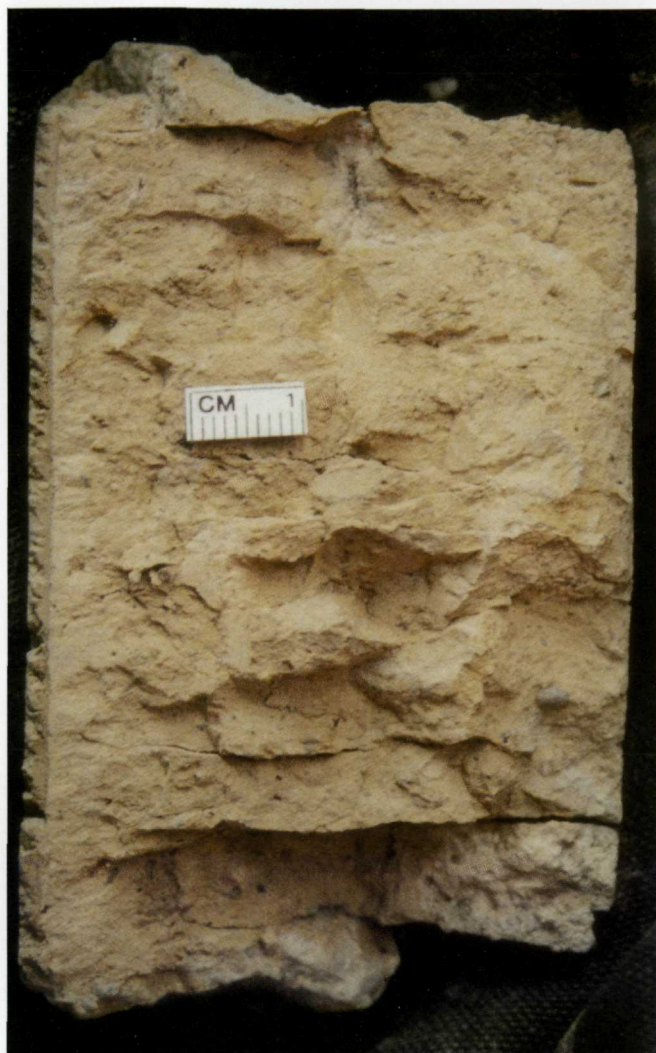
FIGURE 6. Near-surface horizontal fractures in oxidized till at site 1, 1.80 m (5.8 ft) below the surface. Fracture faces are mostly subparallel and about 0.7 cm (0.3 inches) apart, some pinch and swell. Near-surface horizontal fractures were evident in all cores on the till plain to a depth of about 3 m (10 ft). Photo by C. S. Brockman, Ohio Dept. of Natural Resources, Division of Geological Survey (DGS).

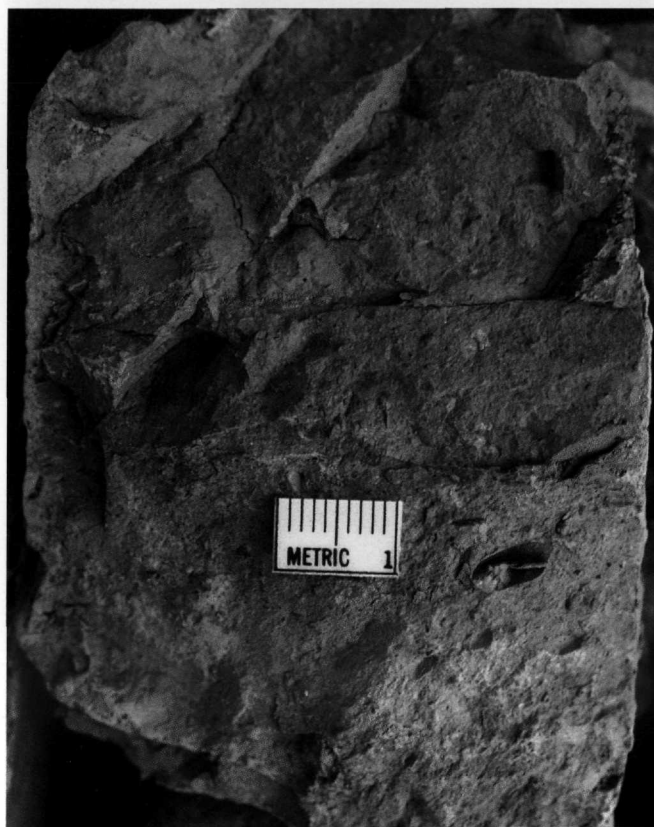
FIGURE 7. Two high-angle fractures (upper left) intersected by a horizontal fracture in clay-loam diamict at site 1, 10.86 m (35.6 ft) below the surface. Photo by C. S. Brockman, DGS.

that were overridden by an ice advance (see Fig. 7). Several regions that have potential for few shear (angled) fractures are those with relatively thick Pleistocene lacustrine deposits that were not overridden by glacial ice, such as the Paulding Clay Basin, Grand River Finger-Lake Plain, and the unnamed lacustrine basins within the Central Ohio Clayey Till Plain (Fig. 10).

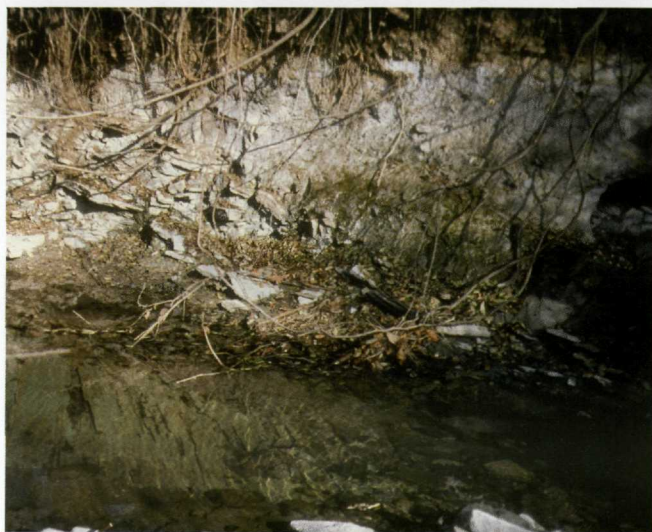
FIGURE 9. A glaciotectionite of slightly dipping limestone and shale bedrock imbedded in Illinoian-age till in the Cincinnati area. Bedrock was sheared only a few decimeters (feet) from its original location; closely spaced parallel shear fractures are visible on the horizontal bedrock surface in the creek. The outcrop is about 1.2 m (4 ft) high. Photo by C. S. Brockman, DGS.

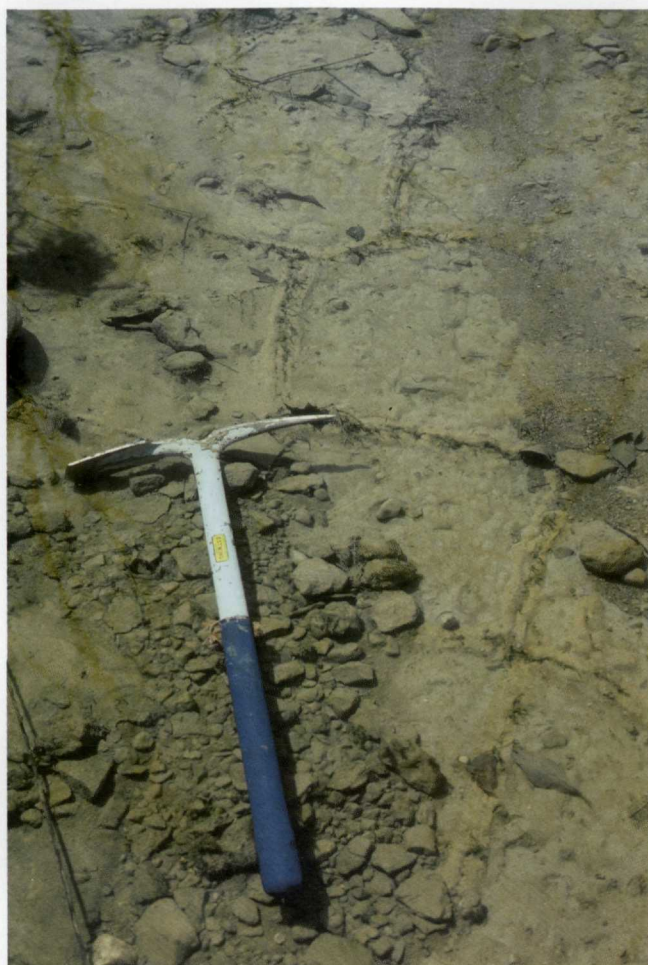
FIGURE 11. Fracture polygons in Illinoian-age till in the Cincinnati area. The polygons are seen through stream water and a light coating of gravel and silt. Vegetation grows within the fractures and an oxidation rind at least 6 cm (2.4 inches) wide stands slightly above the unoxidized interior of the polygon. Hoe-pick is 0.67 m (26.5 inches) long. Photo by C. S. Brockman, DGS.
